Stone Container - Reduction of H₂S, corrosion and related benefits

HISTOSOL OP-Bio5 TREATMENT RESULTS REDUCTION OF BOD

HISTOSOL OP-Bio5 Treatment Results

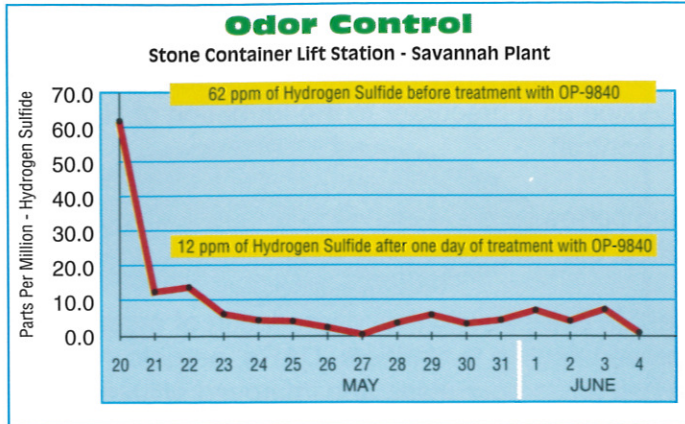
This graph depicts H₂S reduction with 80.6% reduction within the first 24 hours of treatment.

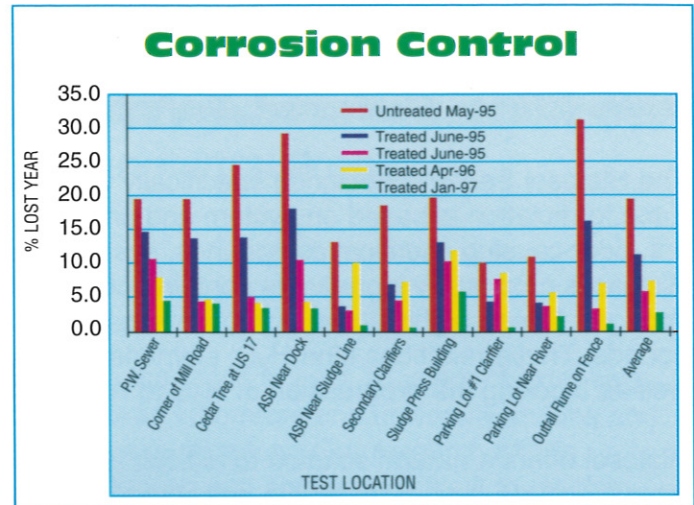
This graph depicts an 87.5% reduction in corrosion over a three-year period. Substantiated by copper corrosion coupon testing.

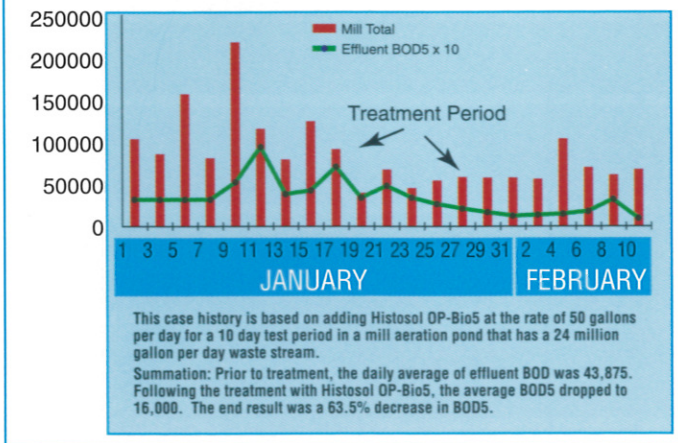
This graph depicts biological enhancement resulting in over-all reduction in final effluent BOD.

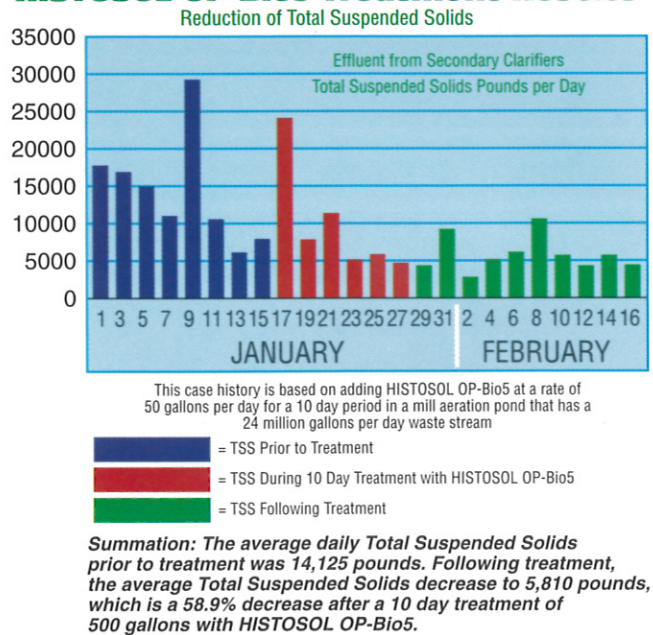
This graph depicts biological enhancement and improved polymer bio-production resulting in over-all reduction in effluent total suspended solids.
